## ILA-USMX JOINT SAFETY COMMITTEE

OSH Circular 2017-10 (12 October 2017)

### 45' Containers Atop On-Deck Tiers

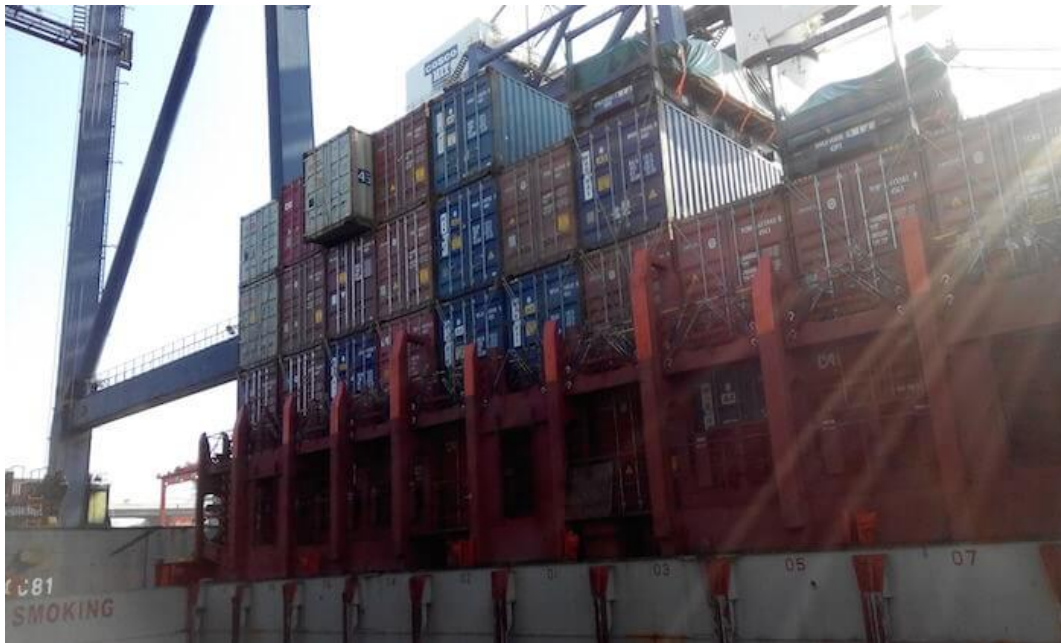
45' containers are often subject to on-deck stowage, generally at the top of a stack; high off the weather deck. When such stowage occurs, it's important for the vessel and stevedoring supervision/foremen to consider the potential for the excess 2.5' of the containers' that overhang lower stows (see photo above) to come into contact with the structure of the container crane working the adjacent stack.

In the incident mentioned above, the crane operator's access stairway made contact with a 45' overhanging container and suffered some significant damage. The operator had to be rescued by a local fire company, and endured a good deal of stress throughout the process. Moreover, the situation could have been worse had there been more significant contact.

Bay plans typically disclose such stows present on incoming vessels. Moreover, a good physical eyeballing of the stows planned to come off the ship will reveal what sort of proximity they may have in relation to cranes that are designated to work the ship. Keep informed! Stay Alert!
