ILA-USMX JOINT SAFETY COMMITTEE

OSH ALERT 2018-07 [06 November 2018]

Guarding Against “Flying Flippers”

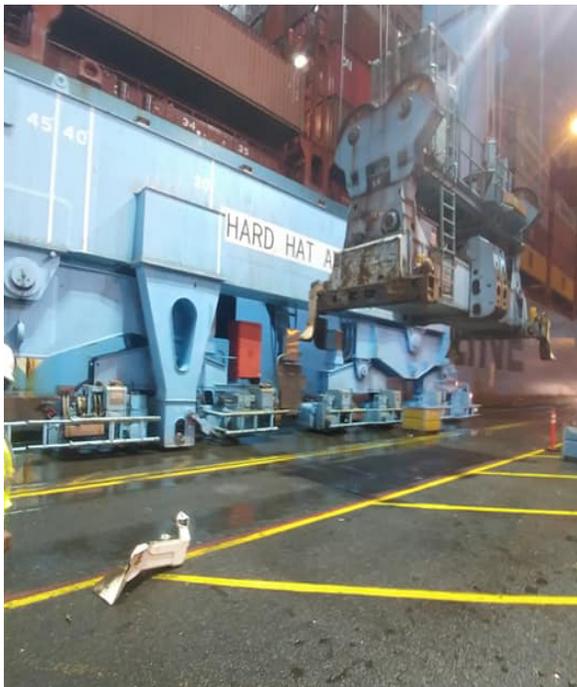
Conscientious condition and maintenance checks should typically provide enough insulation to effectively guard against the obviously dangerous container spreader flipper “free-fall”, an example of which is shown in the photograph *above left*.

Over the last few years, however, the ILA-USMX Joint Safety Committee has been made aware of at least five such flipper “free-falls” occurring worldwide. Frankly, each of these reports are very disturbing. Our view, is that frequent and competent checks of all critical crane components are both a regulatory necessity and an imperative in assuring the proper care and husbandry of the industry’s capital and human resources.

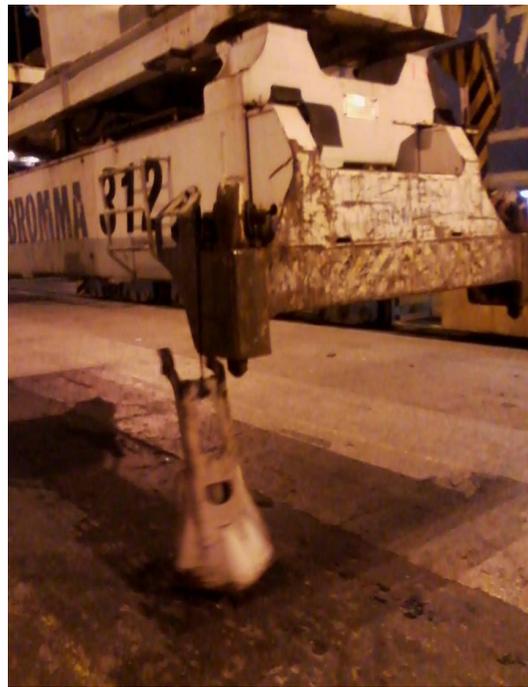
In accounting for worst case scenarios, however, a narrow gauge wire rope preventer (an example of which is shown in the photograph *above right*) rigged between the base of each flipper and the spreader’s frame (taking care not to foul any necessary mechanical movement) will limit the drop of any flipper becoming unshipped; for any reason.
