ILA-USMX JOINT SAFETY COMMITTEE

OSH ALERT 2023-04 [17 March 2023]

Lashing Bridge Hatchways

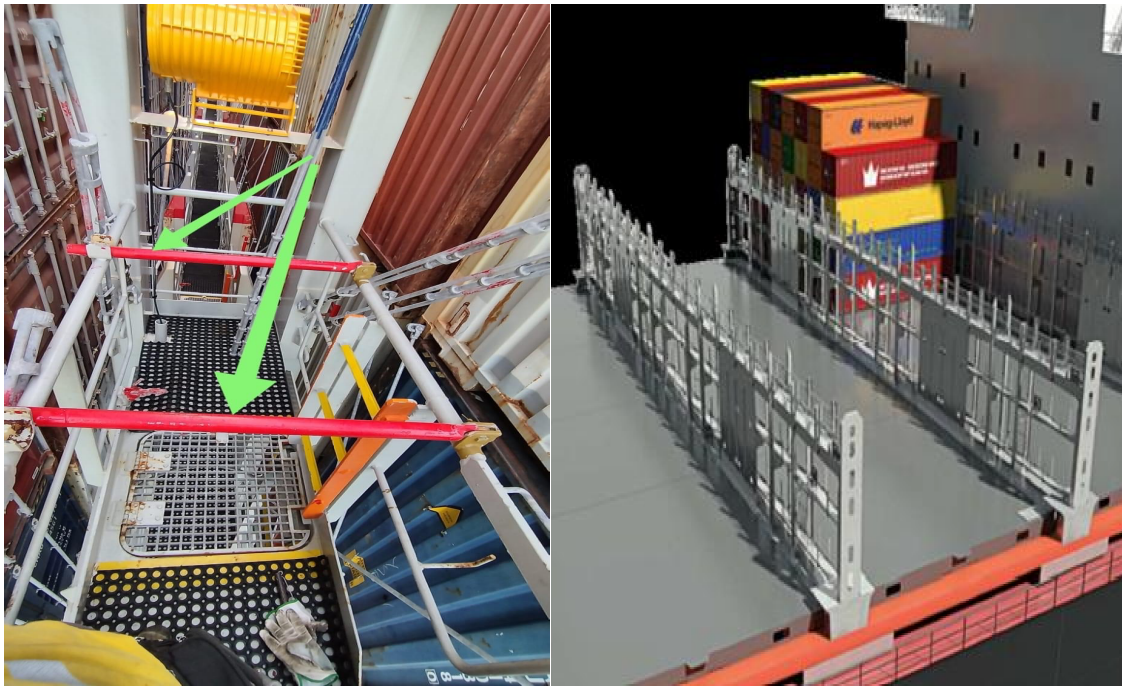
Since the introduction of lashing bridges, one of the most frequently occurring accidents observed globally involves lashers who fall through open lashing bridge hatchways.

Lots of mitigating efforts have been attempted, including the installation of fore & aft elevating walkway pipe guards on some ships (**See** photo above left).

What if regular ship's maintenance included the painting of those hatchway grates a brilliant "Safety Yellow?" Then, it could be reasoned that if the brilliant "Safety Yellow" color was not present to the eye of the person on the walkway... something could be wrong and greater care would be exercised in response. Is it worth a try? In light of the potentials involved: Yes....
