## ILA-UMX JOINT SAFETY COMMITTEE

OSH Circular 2013-05 [10 July 2013]

### 2 Pallet-Wide Containers

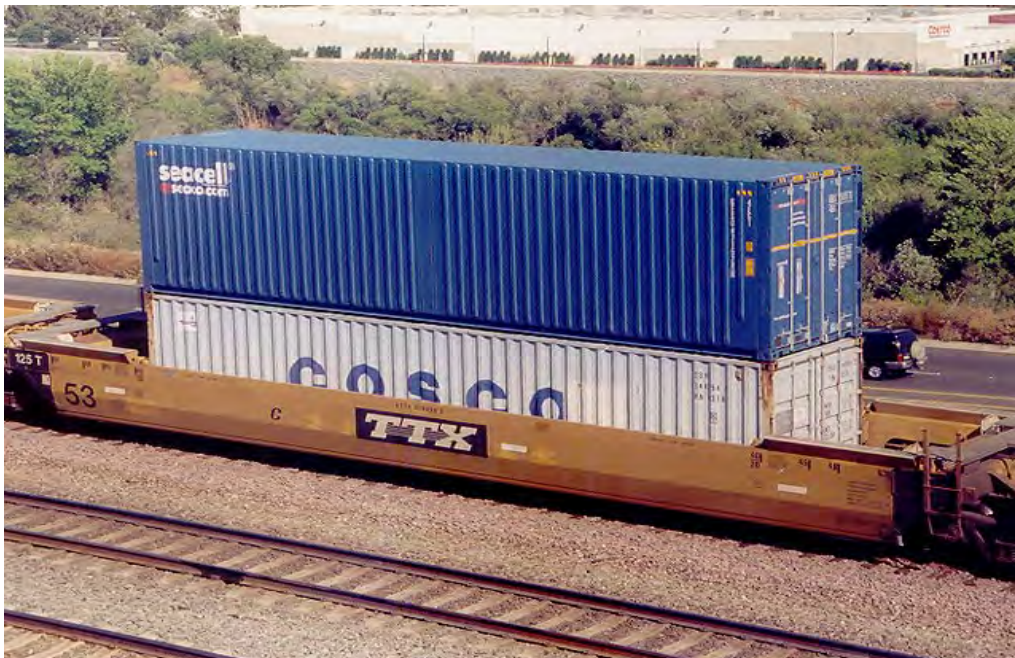
For several years now, the European shipping market has been experimenting with intermodal containers whose internal dimensions have been enlarged to accommodate 2 pallet loads (side-by-side; across the container's width). In order to achieve those internal dimensions, the container's side walls must each be pushed out approximately 1.3 inches. This is achieved by (more or less) reversing the sidewall corrugations. Here's a photo that shows a 2 pallet wide (or SeaCell®) container atop a standard 40 foot container in rail gondola stowage:

Containers of this design are lifted in precisely the same manner as all other intermodal containers. They come in 20', 40' & 45' lengths. (standard & high cube [up to 9' 10"] varieties). Their corner fittings conform to the normal 20', 40' and 45' container positions. The sidewalls, however, as pointed out above, are pushed out slightly to accommodate 2 pallet-wide loads. Of late, we have observed a slight increase in the number of these containers entering US ports. It's difficult to know whether that trend will continue or not. Either way, the ILA-UMX Joint Safety Committee (JSC) would like to draw your attention to some subtle safety hazards that could be experienced by cargo handling personnel.

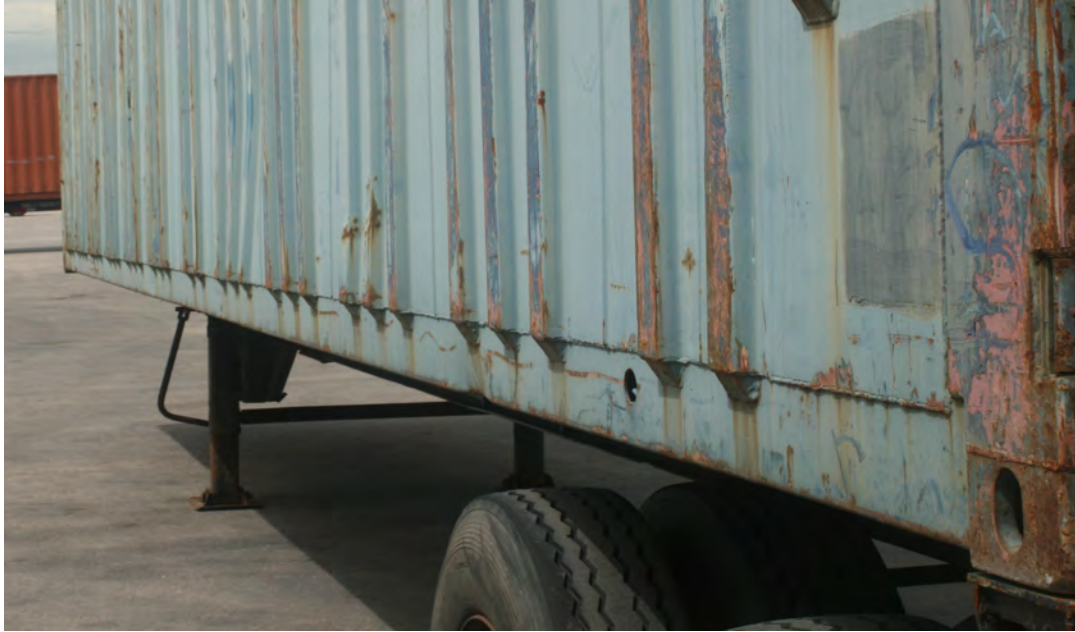
The photo above shows how the expanded corrugated surface extends marginally past the bottom rail of a 2 pallet-wide intermodal container. When the sidewall dimensions of this type of container are taken together, nearly three inches of overall width are added to the box. That's enough extra width to cause potential safety hazards when placing them in or removing them from bomb carts, in the accommodation of that width in the case of both on deck and below deck stowage and potentially when forming the lower tier of a rail gondola. **PASS THE WORD; TELL YOUR CO-WORKERS; BE SAFE!**
